JOINT OIL ANALYSIS PROGRAM MANUAL

VOLUME III

LABORATORY ANALYTICAL METHODOLOGY AND EQUIPMENT CRITERIA (AERONAUTICAL)

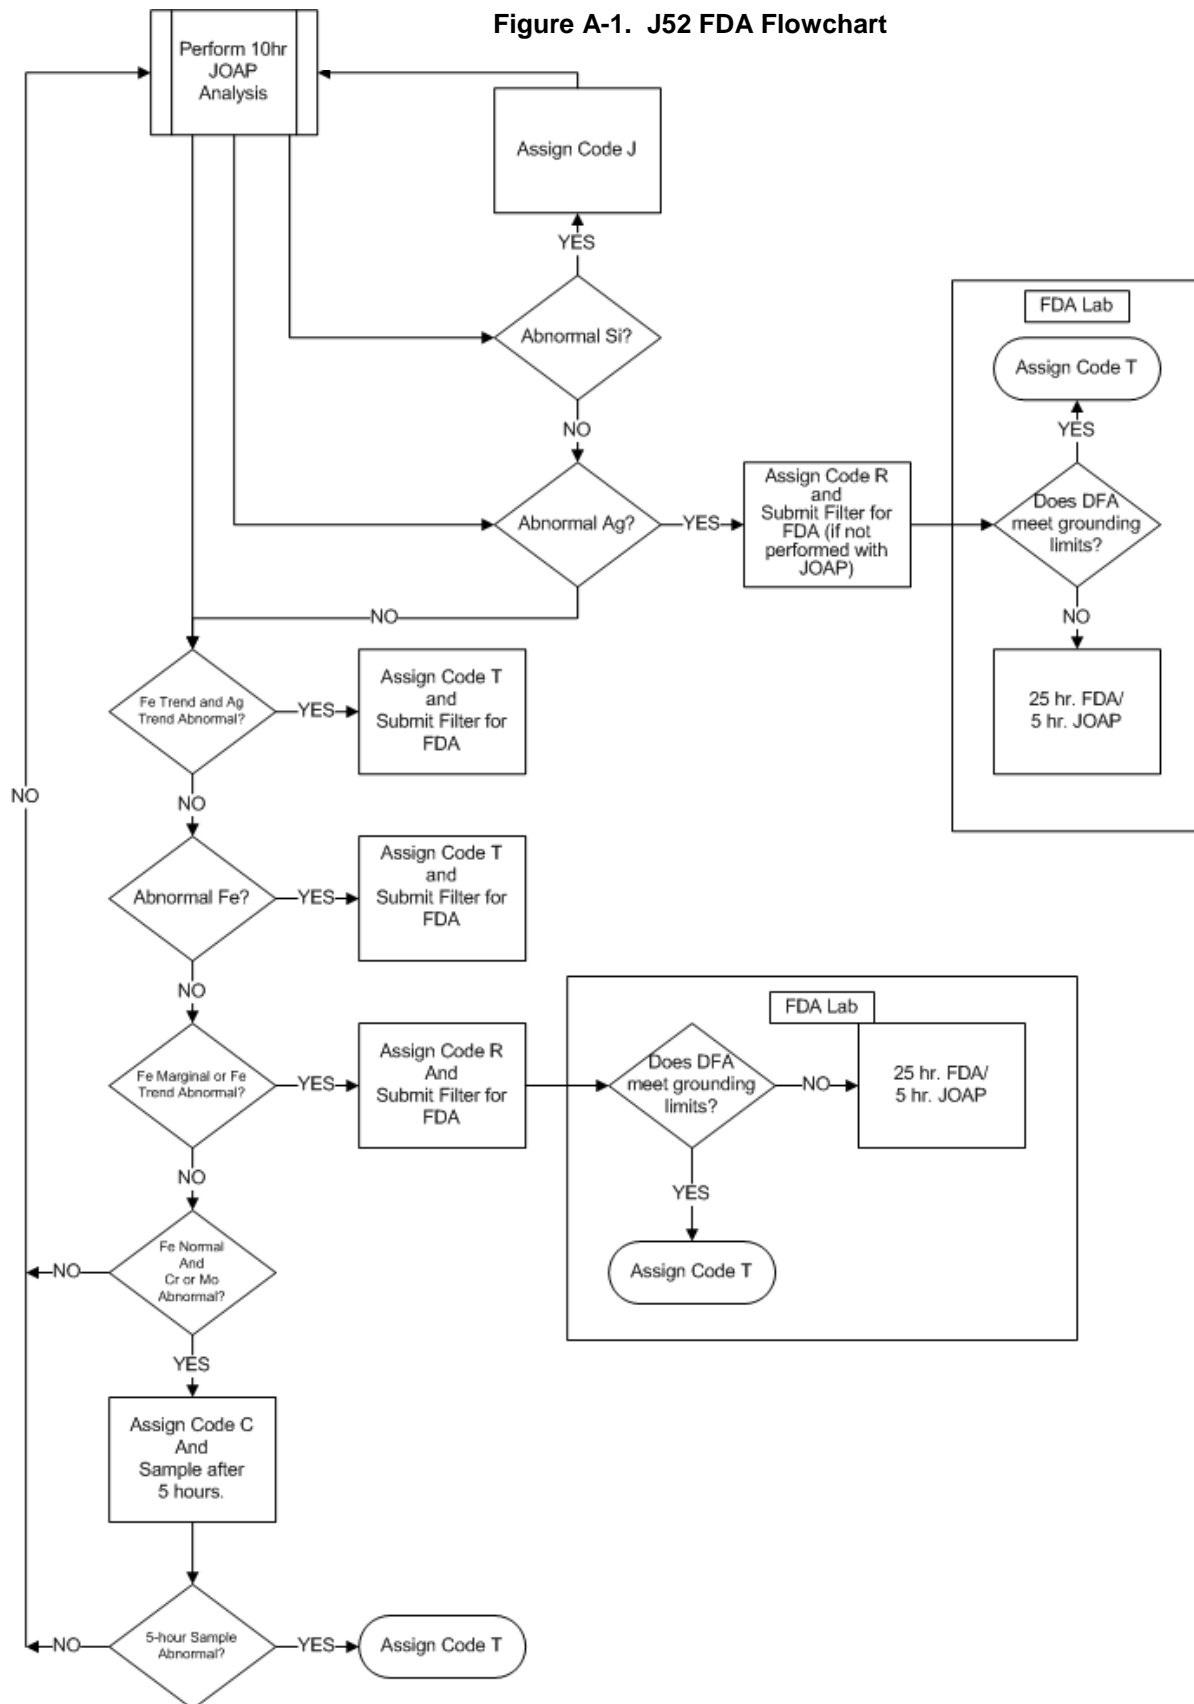
Figure A-1. J52 FDA Flowchart

1. If the Fe trend is at or exceeds the abnormal trend limit, AND if ANY ONE of the following elements: Ag, Cr or Mo is at or exceeds the abnormal trend limit issue advice code T, do not fly or operate, recommend engine removal..

2. If the Fe trend and the Ag trend is at or exceeds the abnormal trend limit, issue advice code T, do not fly or operate, recommend engine removal.
3. If the Fe is in the high range or the trend for Fe meets or exceeds the table limit, recommendation shall be code R, do not fly or operate, inspect filter using FDA. If the FDA inspection meets grounding criteria, assign code T, do not fly or operate, recommend engine removal. If the FDA inspection does not meet grounding criteria, place filter on a 25 hour cycle, place JOAP oil sampling on a 5 hour interval until results return to normal.

4. If Cr and/or Mo are abnormal and the Fe is in the normal range, recommend code C, resample after 5 hours, do not change oil. If the resample is abnormal, assign code T, do not fly or operate, recommend engine removal.

5. If Ag is abnormal, recommend code R, do not fly or operate, inspect filter using FDA. If the FDA inspection meets grounding criteria, assign code T, do not fly or operate, recommend engine removal. If the FDA inspection does not meet grounding criteria, place filter on a 25 hour cycle, place JOAP oil sampling on a 5 hour interval until results return to normal.

6. IF Si is abnormal, recommend code J, contamination confirmed, change oil, resample with normal sampling schedule.

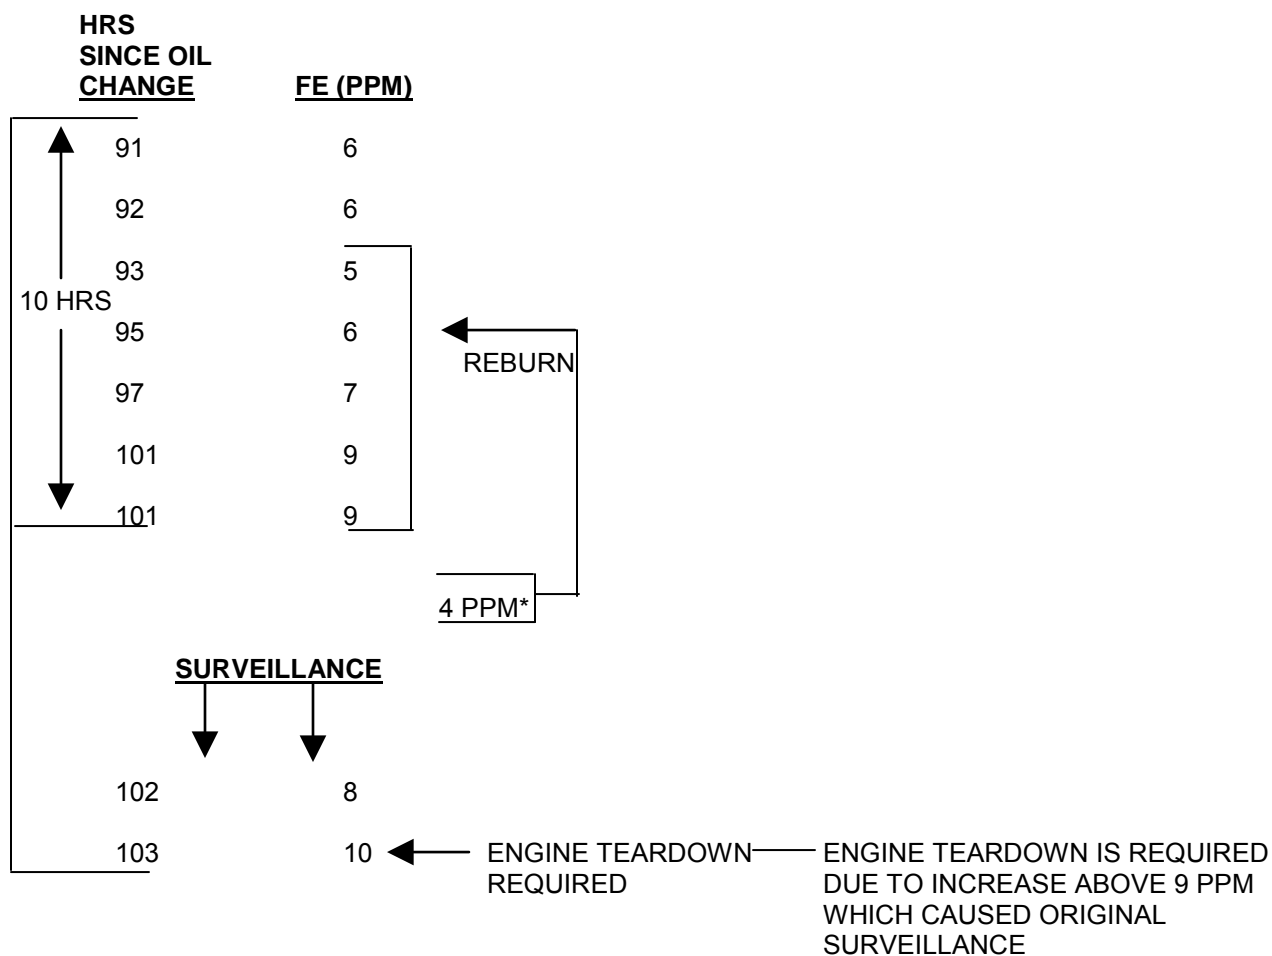
EXAMPLE: PRIOR TO SURVEILLANCE
 (FOR FE INCREASE IN 10 ENGINE HOURS)

JOAP RECORD ACTION REQUIRED REASON

* 4 PPM or greater using JOAP Atomic Emission.
